THE CALIFORNIA EARTHQUAKE OF APRIL 18, 1906

STATE EARTHQUAKE INVESTIGATION COMMISSION

IN TWO VOLUMES AND ATLAS

ANDREW C. LAWSON, CHAIRMAN

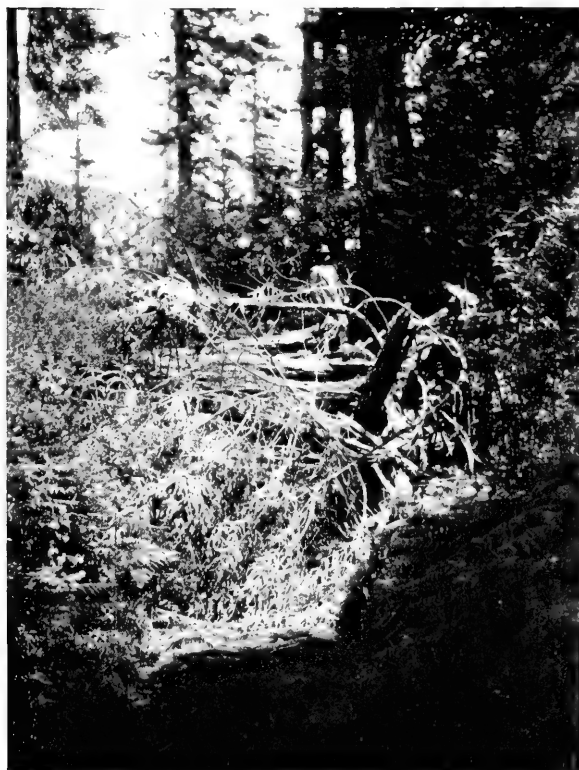
C. Uprooted tree, 8 feet in diameter, 187 feet long, about half mile west of Garcia River, on road to Garcia Mill. Tree sound. F. E. M.

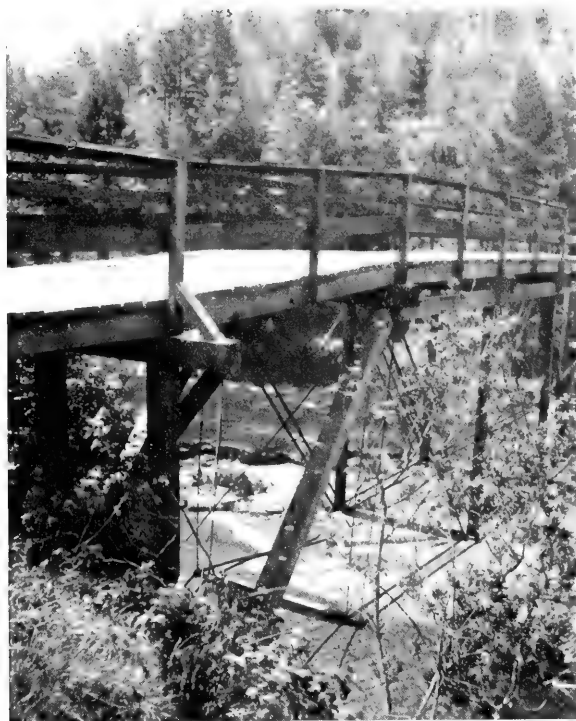
D. Bridge over South Fork, Gualala River, 3 miles east of Stewart's Point, looking north. Bridge floor and panels bent; tension rods buckled. F. E. M.

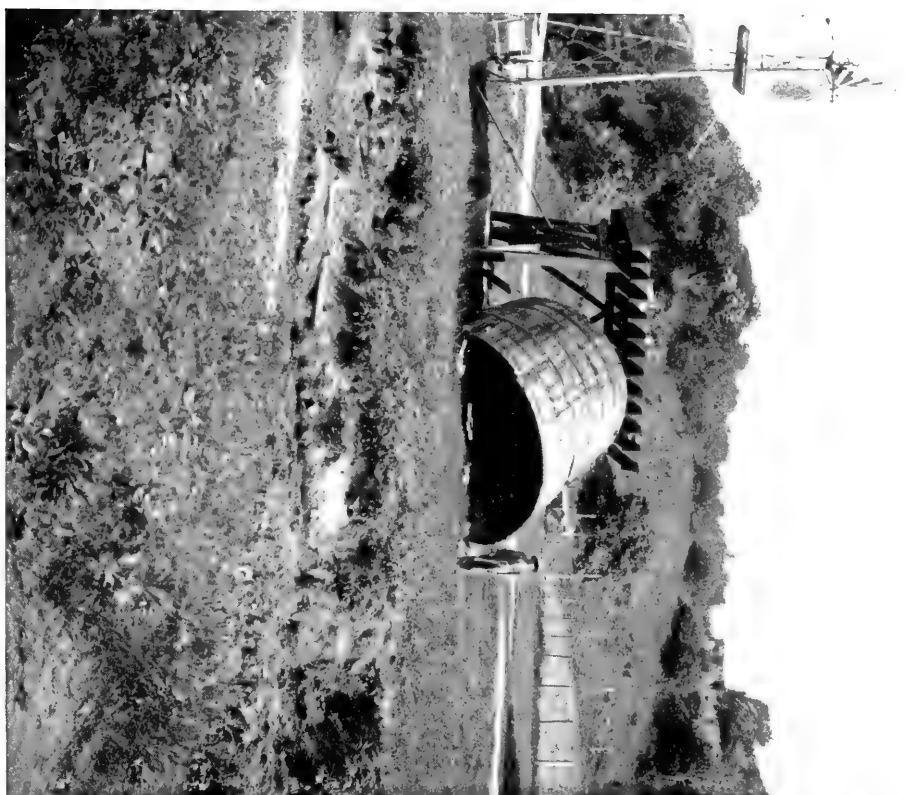
B. Wrecked water-tank, near Inverness. G. K. G.

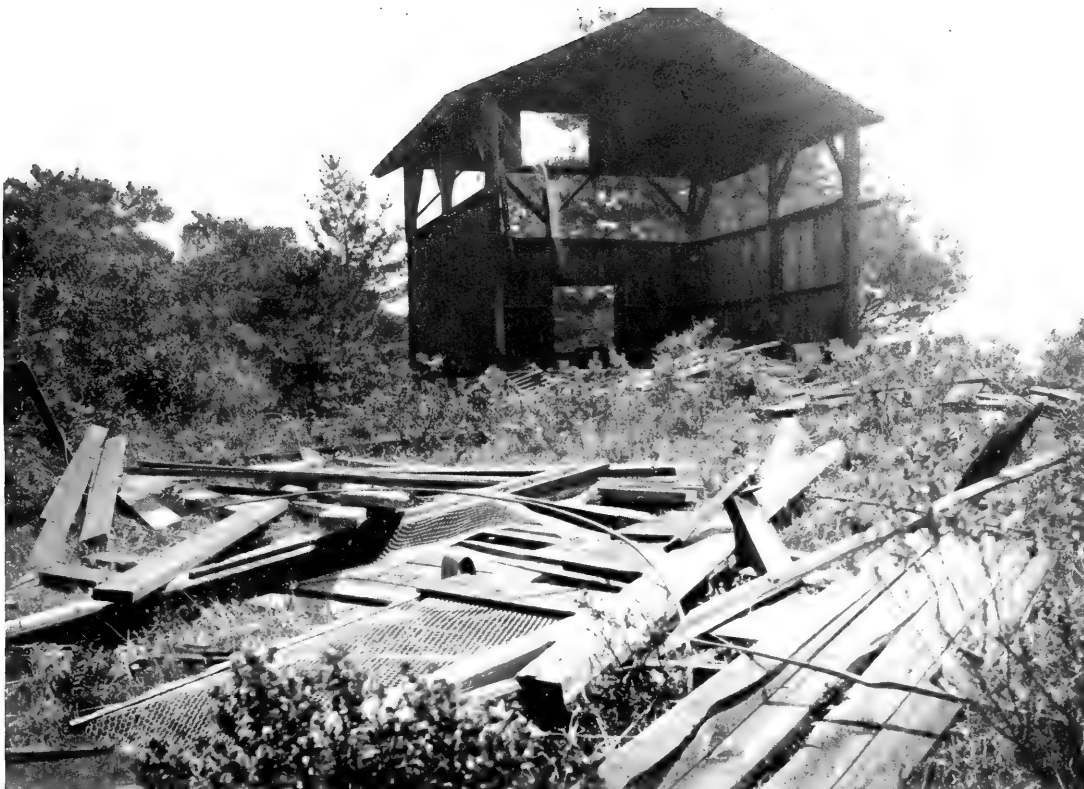
A. Ruin of Inverness reservoir, a circular tank which before earthquake stood in shed. Parts of shed also lie in foreground, about 50 feet from original position. G. K. G.

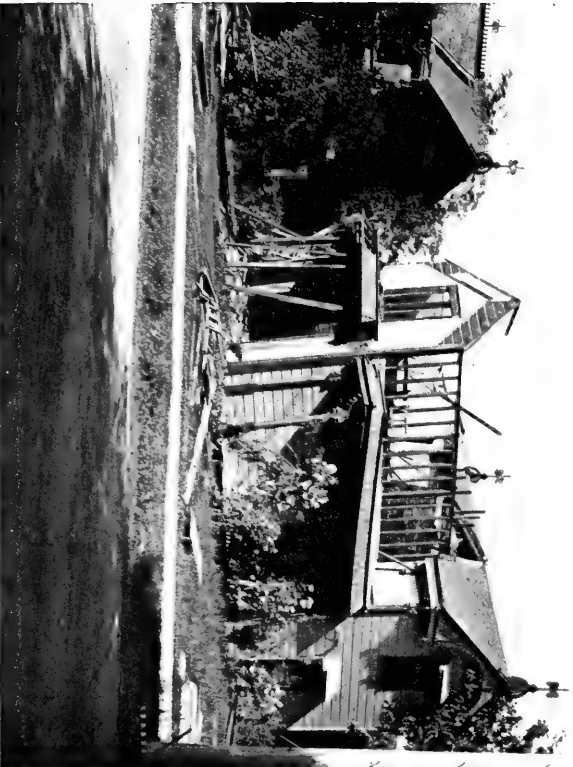
C. Wrecked dwelling, Santa Rosa. R. S. H.

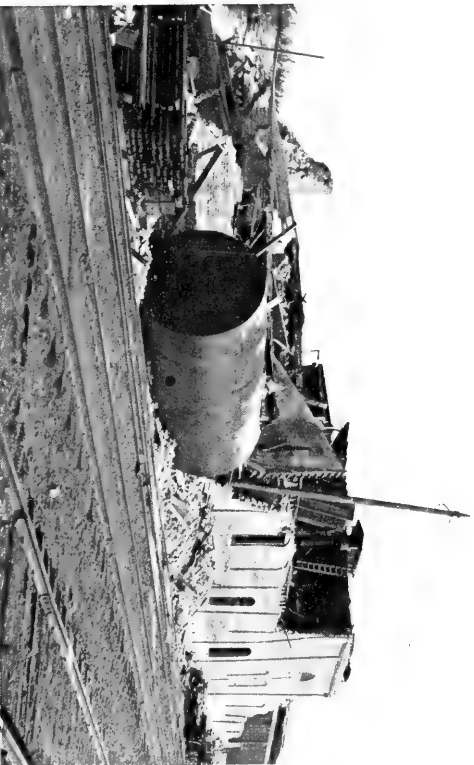
D. Wreck of brick structure, Santa Rosa. R. S. H.

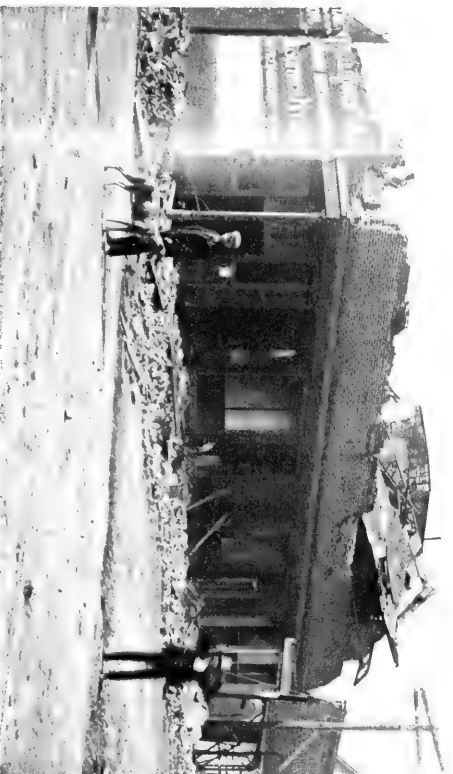
B. Wrecked buildings, Sebastopol. R. S. H.

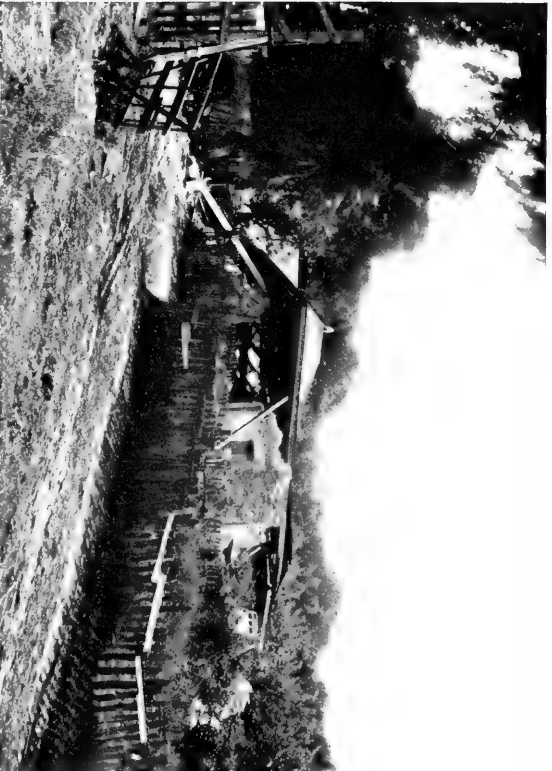
C. Stone house 1.5 miles southeast of Tomales, where two people were killed at time of earthquake. R. S. H.

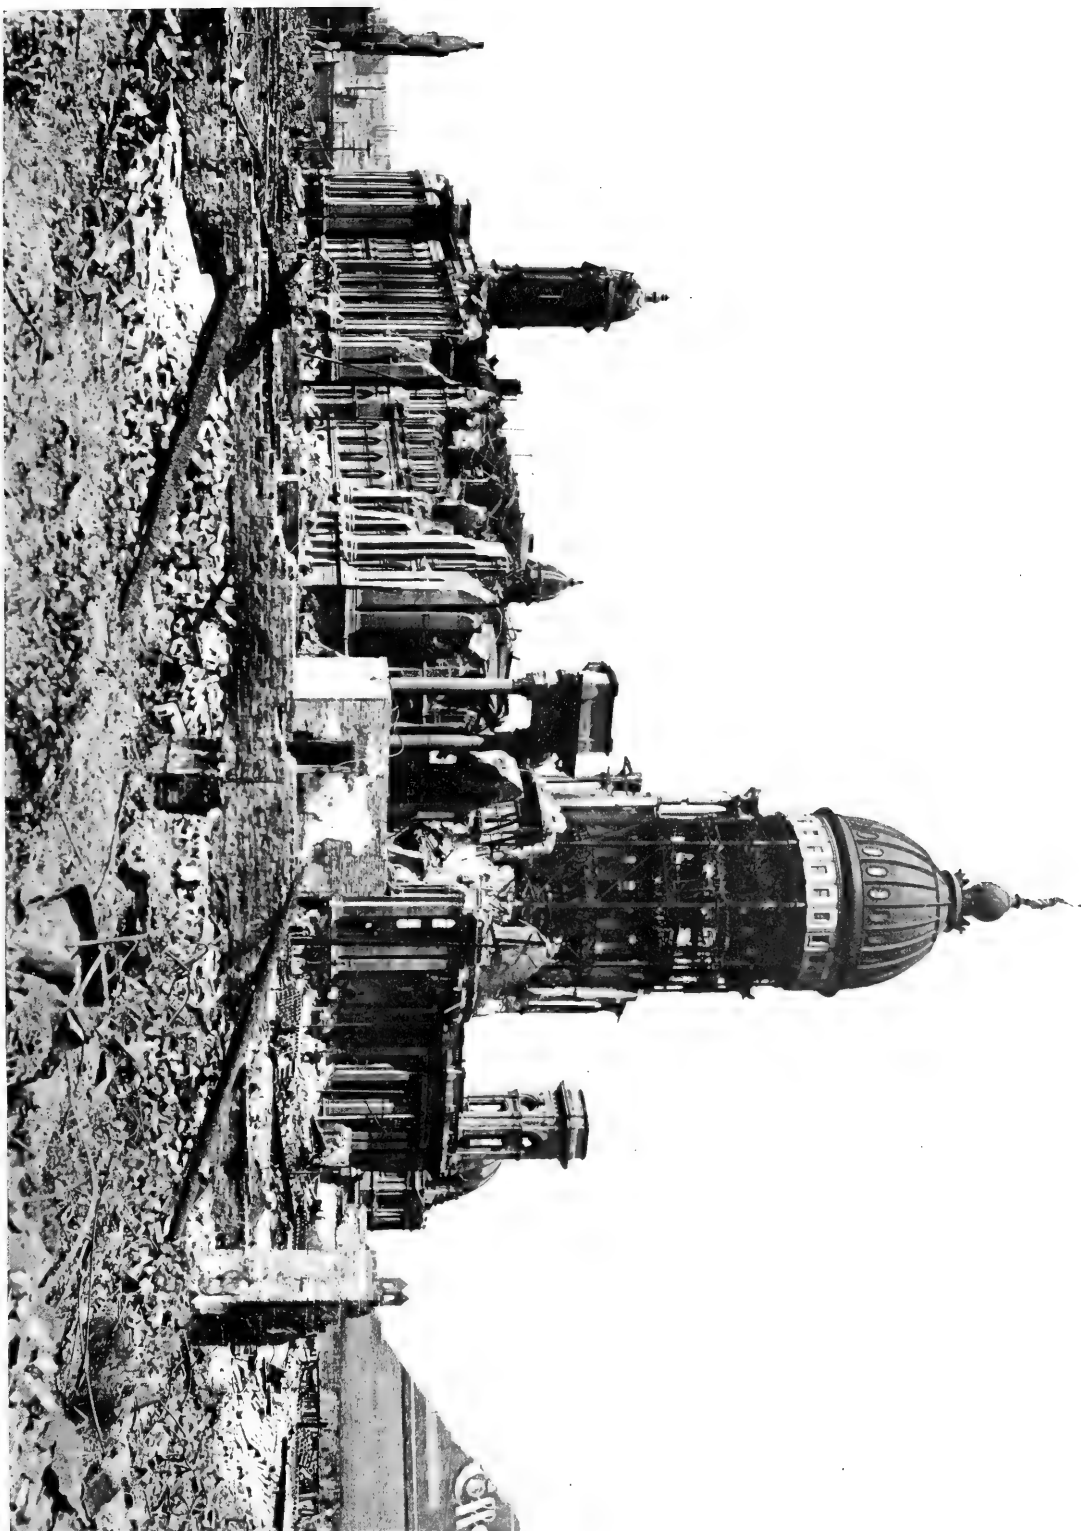
City Hall, San Francisco.

Near the City Hall there was a small locality conspicuous for the damage produced. The City Hall itself made a picturesque ruin (plates 82 and 83A), as all the world knows, but the character of the construction was probably a large factor in its destruction. Nevertheless ugly cracks in other buildings near by indicated intensity somewhat higher than was common in the valley district as a whole.

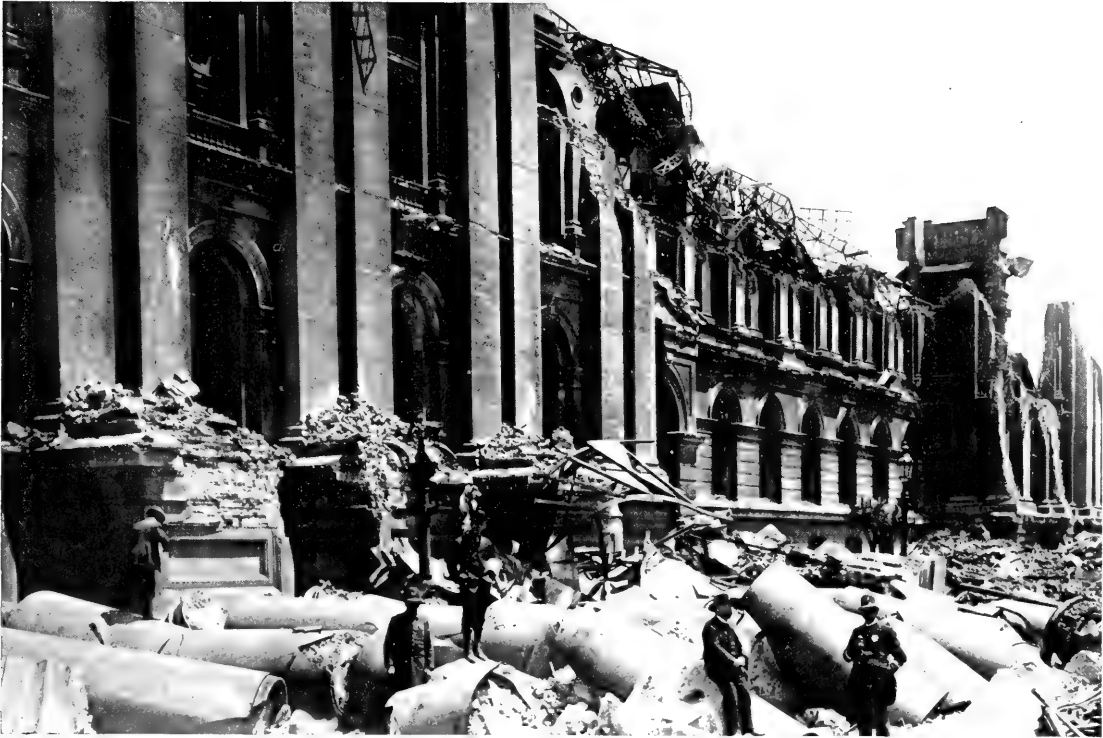
A. A near view of the wreck at the City Hall, San Francisco.

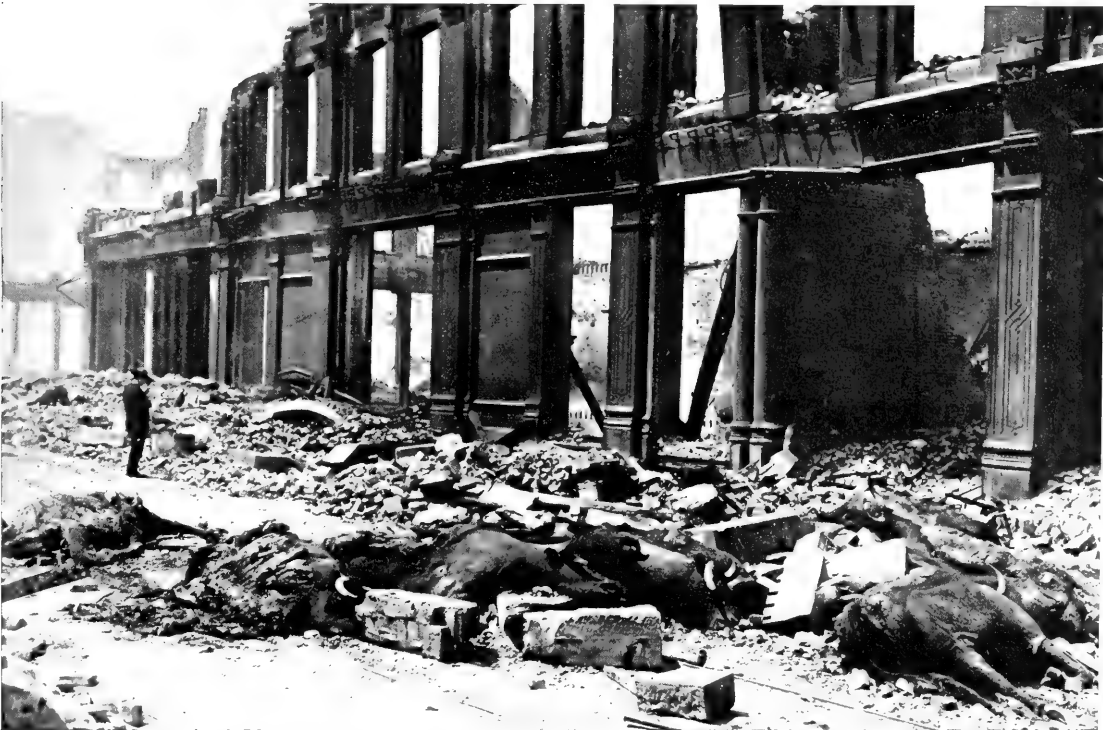
B. Cattle killed by falling masonry at time of earthquake, San Francisco.

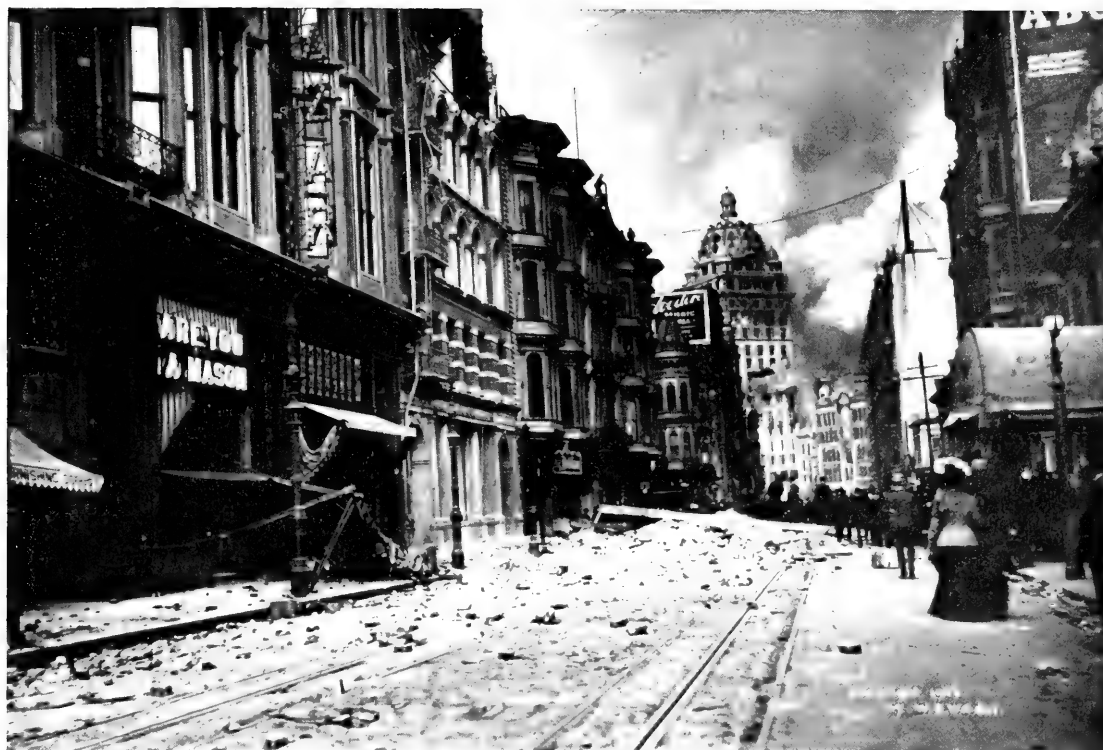
A. O'Farrell Street, San Francisco, after earthquake and before fire.

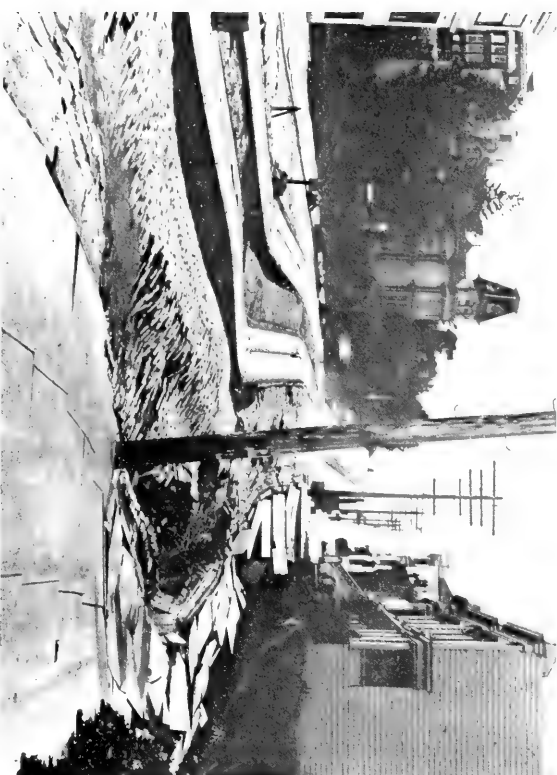
B. Slip of a fill on Union Street, just west of Steiner Street, San Francisco. H. O. W.

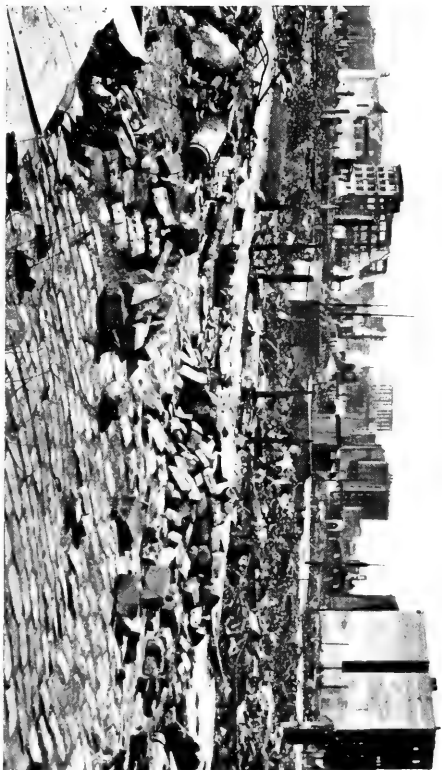
C. Russ Street, between Folsom and Howard Streets, San Francisco. Paving blocks forced up into sharp arches and dislodged by compression. H. O. W.

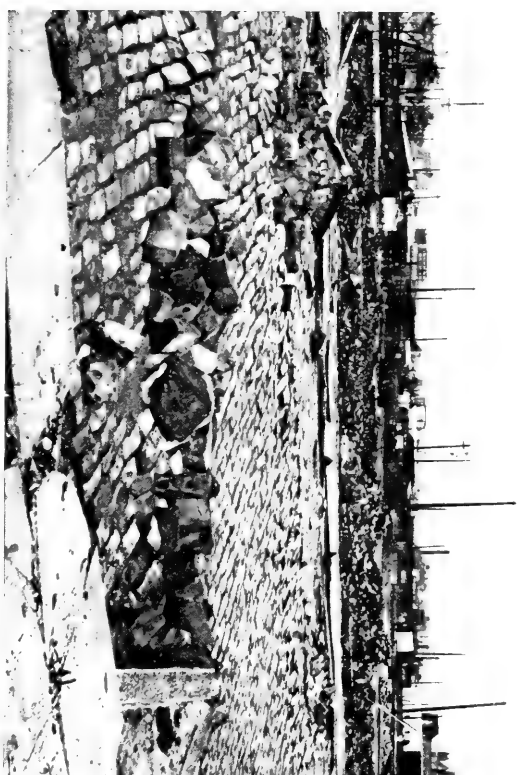
D. Moss Street, between Folsom and Howard Streets, San Francisco. Paving blocks arched by compression along sinuous crest, curbing thrown into an inverted V. H. O. W.

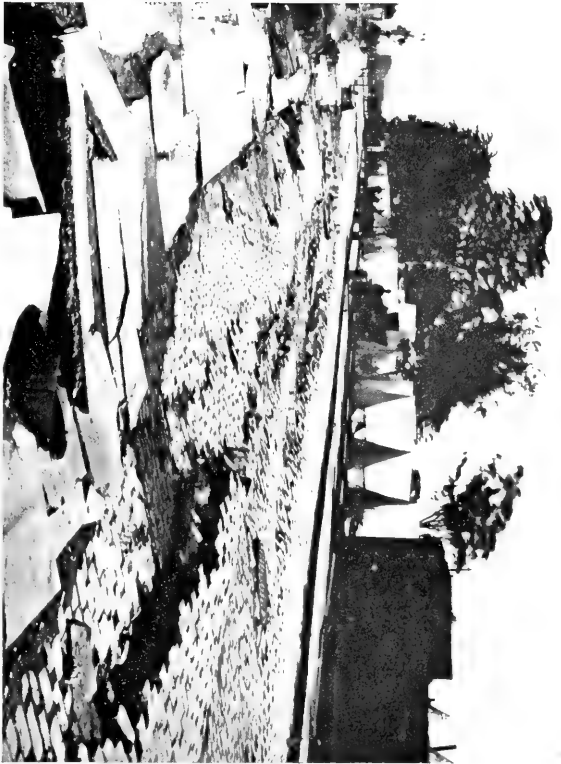
A. Columbia Street, just south of Polson Street, San Francisco. Slumping, depression, and furrowing of block pavement. H. O. W.

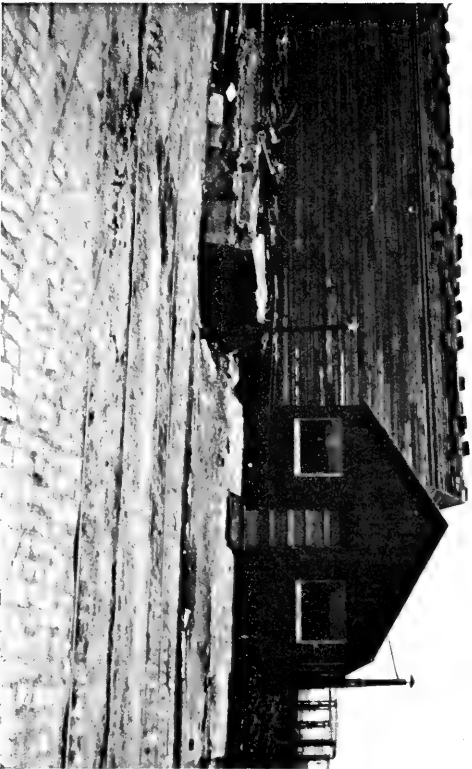
C. Sixth Street, near Howard. Once occupied by marsh. Street dropt nearly 3 feet. Sidewalk held up by piling foundation of a building. H. O. W.

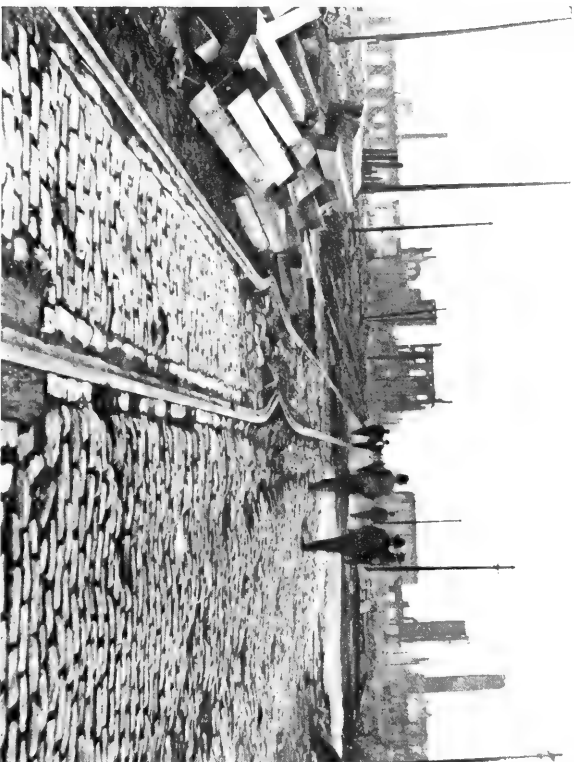
B. Bryant Street, near Fourth Street, San Francisco. Flexure of heavily ballasted car tracks in block pavement; an effect of sharp compression. H. O. W.

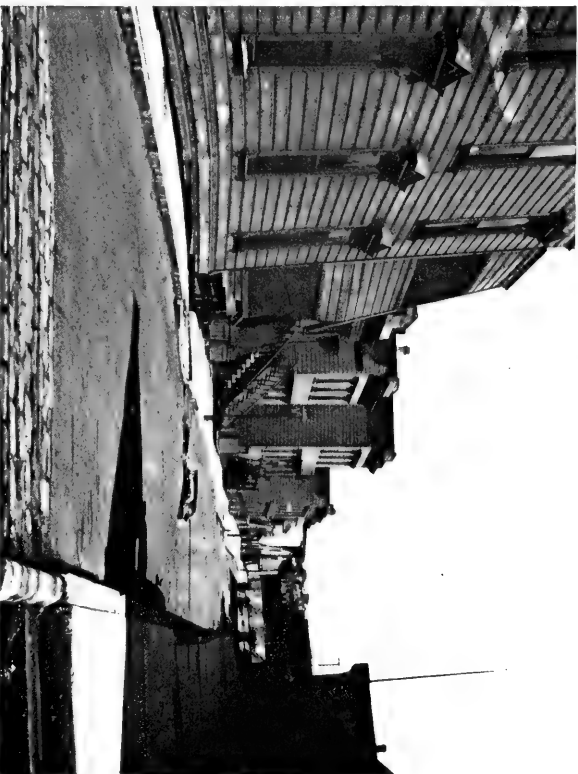
D. Looking along Dore Street, from Bryant toward Brannan. Undulating and fractured condition of pavement due to earthquake. Houses thrown off their underpinning and pitched out of the vertical. H. O. W.

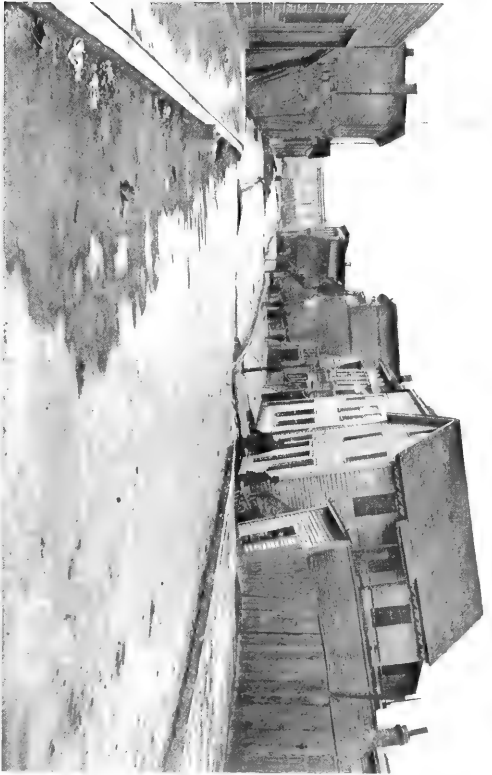
A. Looking along Dore Street from Brannan toward Bryant. Larger undulations near Brannan. Dore Street is on site of an arm of Mission Creek. H. O. W.

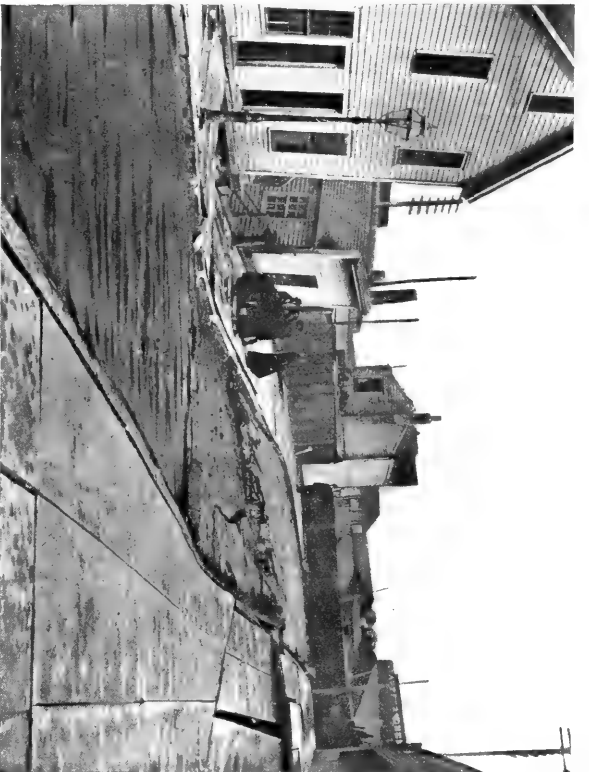
B. Dore Street, near Brannan. Vertical difference between crest and trough of undulations, 5 feet. H. O. W.

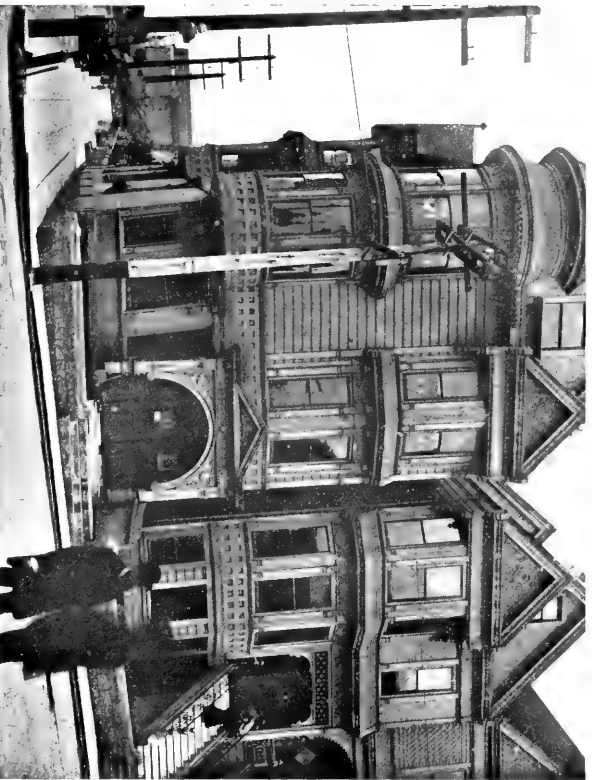
D. Southwest corner Fortola and Waller Streets. Buildings have shifted down hill slightly, upper parts more than lower. H. O. W.

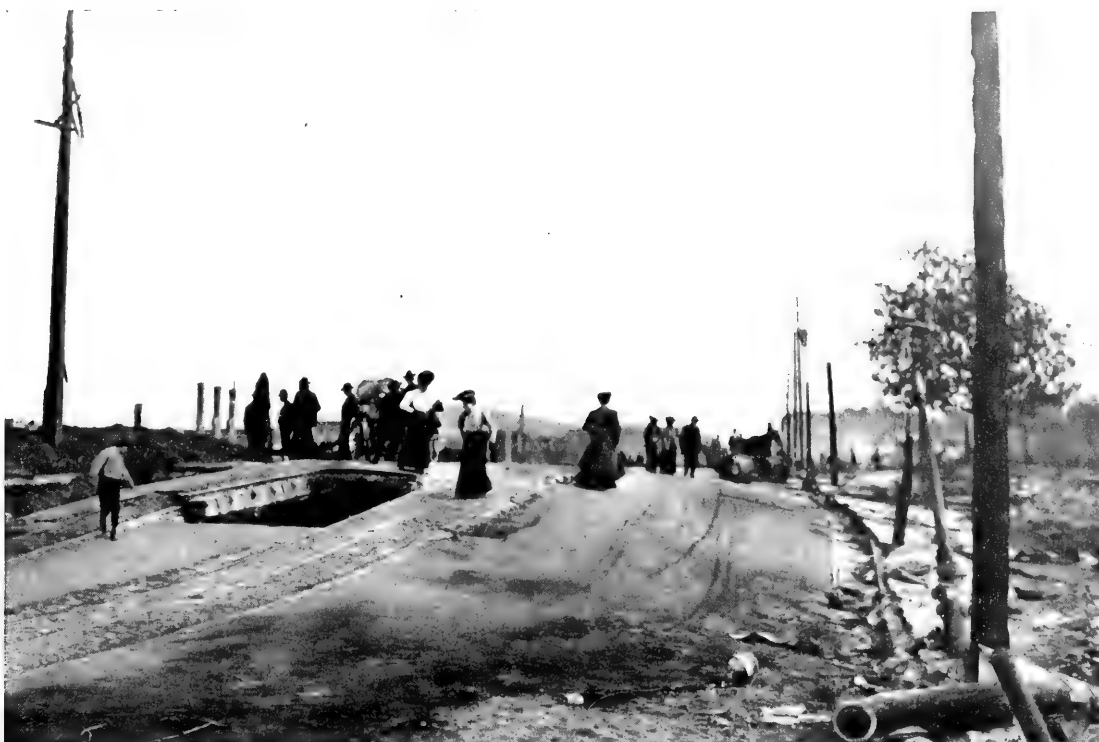
B. Valencia Street, near Eighteenth. Land in this neighborhood sank about 6 feet, flexing street surface. A. C. L.

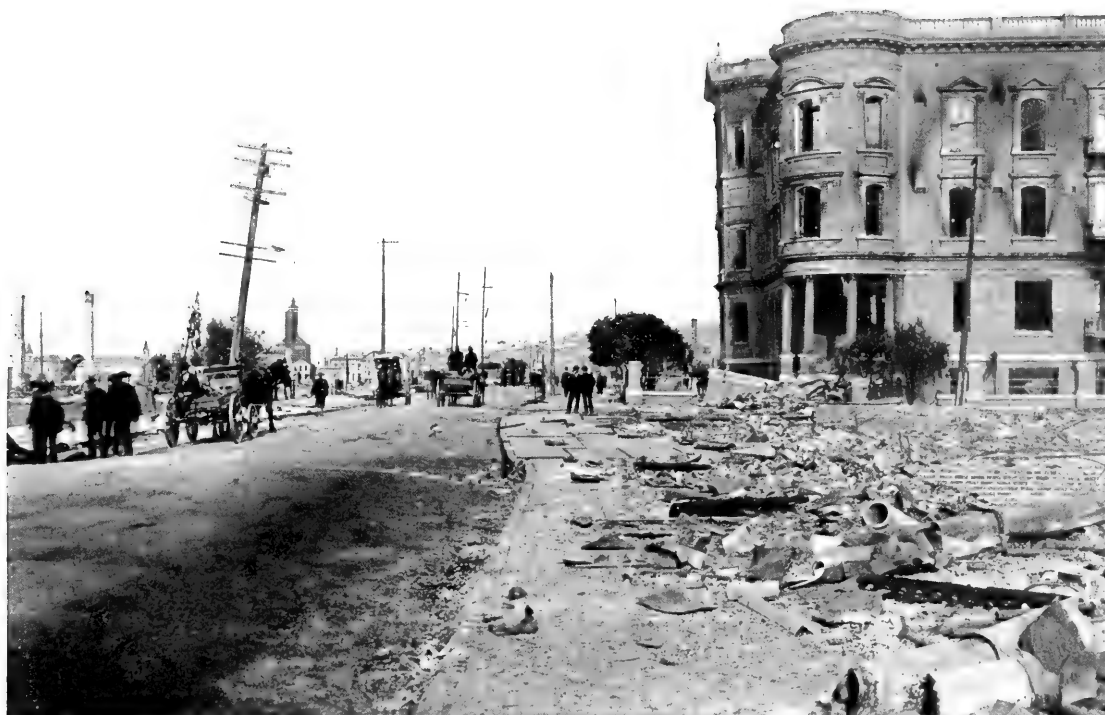
A. View along Nineteenth Street, from Guerrero Street. Both ground and buildings moved north about 6 feet toward center of old marsh, with component of movement down the channel. A. C. L.

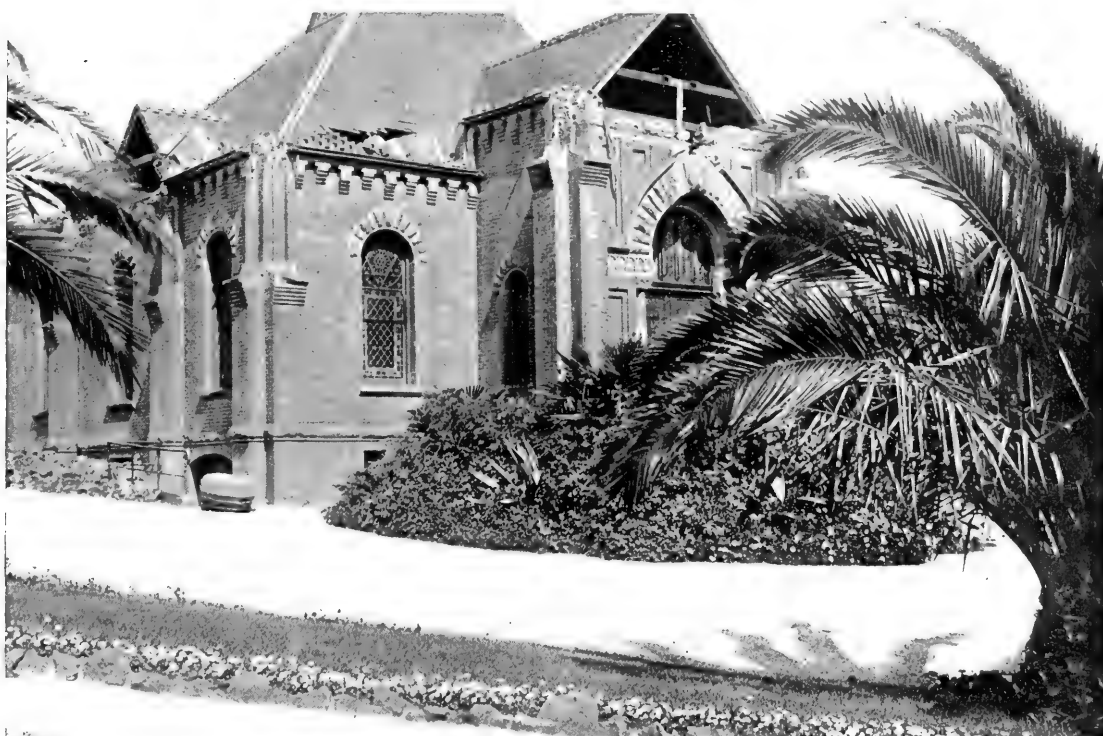
B. Hills of Eternity Cemetery, south of San Francisco. All four gables thrown out. Parapets thrown in on roof. A. C. L.

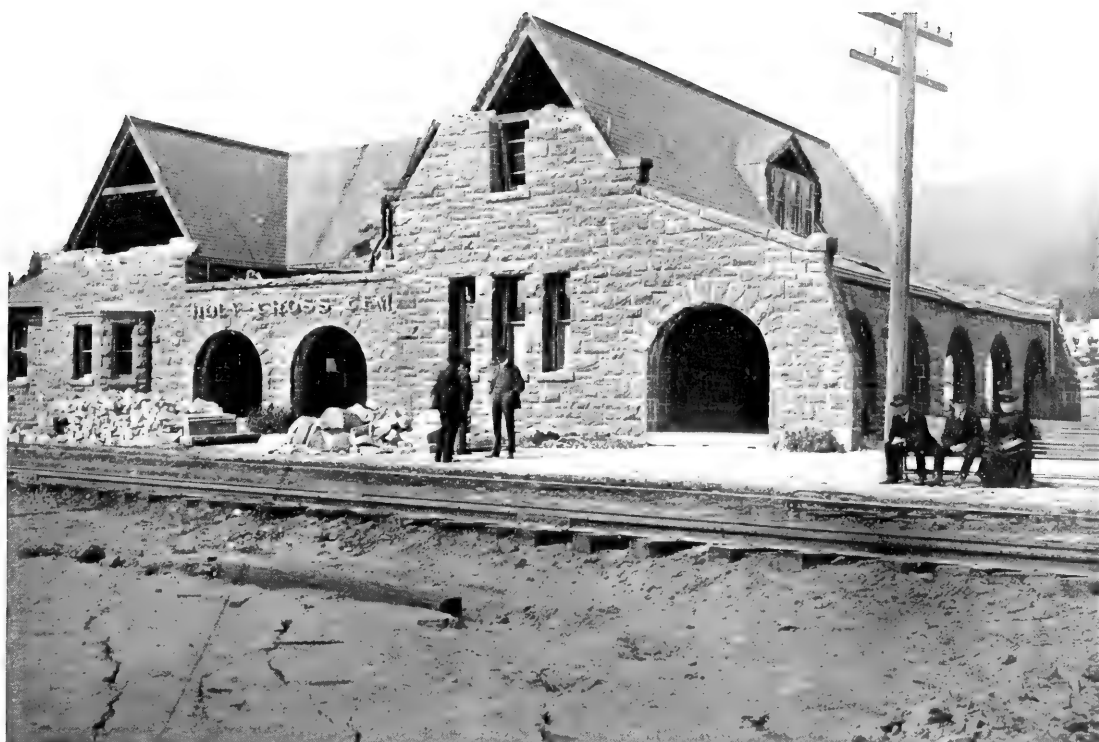
A. Holy Cross Cemetery Station, south of San Francisco. Building on made ground. A. C. L.

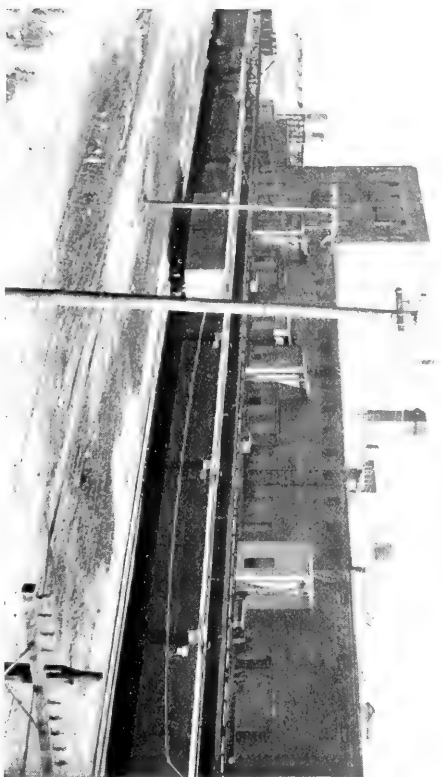
B. Brick building and high chimney left standing. South San Francisco. R. B. M.
